Gradual Reduction of PV Generator Yield due to Pollution

H. Haeblerlin and J. D. Graf

Berner Fachhochschule

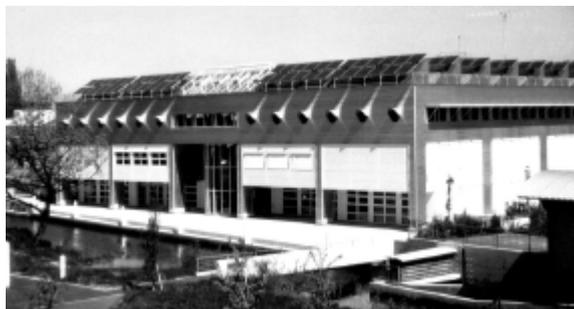
Fig. 1: View of the building of the department of Electrical Engineering of HTA Burgdorf with a PV generator of 60kWp on top of the roof.

A main railway line passes about 10m behind the point where the picture was taken.

The most important external source of unusual pollution is a main railway line (Berne-Zurich) at a distance of only about 50m. As the railway station of Burgdorf, where many trains stop, is less than 1 km away, many trains are braking or accelerating when they pass the building. The region is pretty humid, natural rainfall is more than 1000 liters per m² a year and is distributed sufficiently over the whole year, thus natural cleaning of the array was considered to be sufficient before installation of the plant.

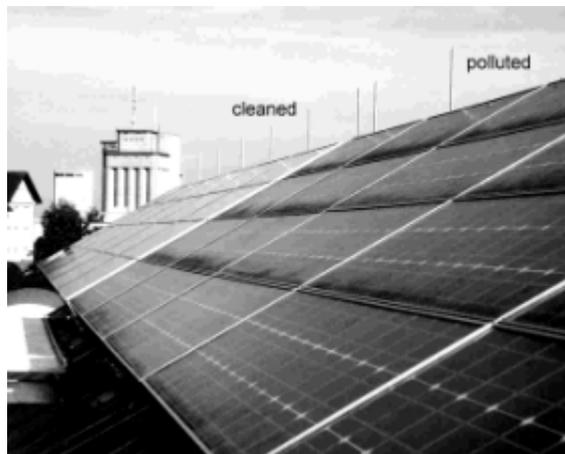
Fig. 2: View of a part of the PV array with visible pollution. The modules at the left side are cleaned, whereas the others show the pollution accumulated from summer 1993 to fall 1997.

While in the years 1994 till 1996 only in spring a clearly visible pollution was observed, in course of 1997 with a rather dry and sunny period from the end of July until the beginning of November, a development of a *permanent* pollution strip (compact pollution up to 1 cm, followed by a strip of visible, but not compact pollution) close to the lower edge of the module frame was registered. The influence of this polluting strip on array performance was especially severe on the modules of the main generator (with the long side in horizontal position), because the distance between cells and frame is very small there (1-2 mm).
