# SOLAR PANEL'S LOSS OF YIELD

*Guidelines for a proper cleaning*

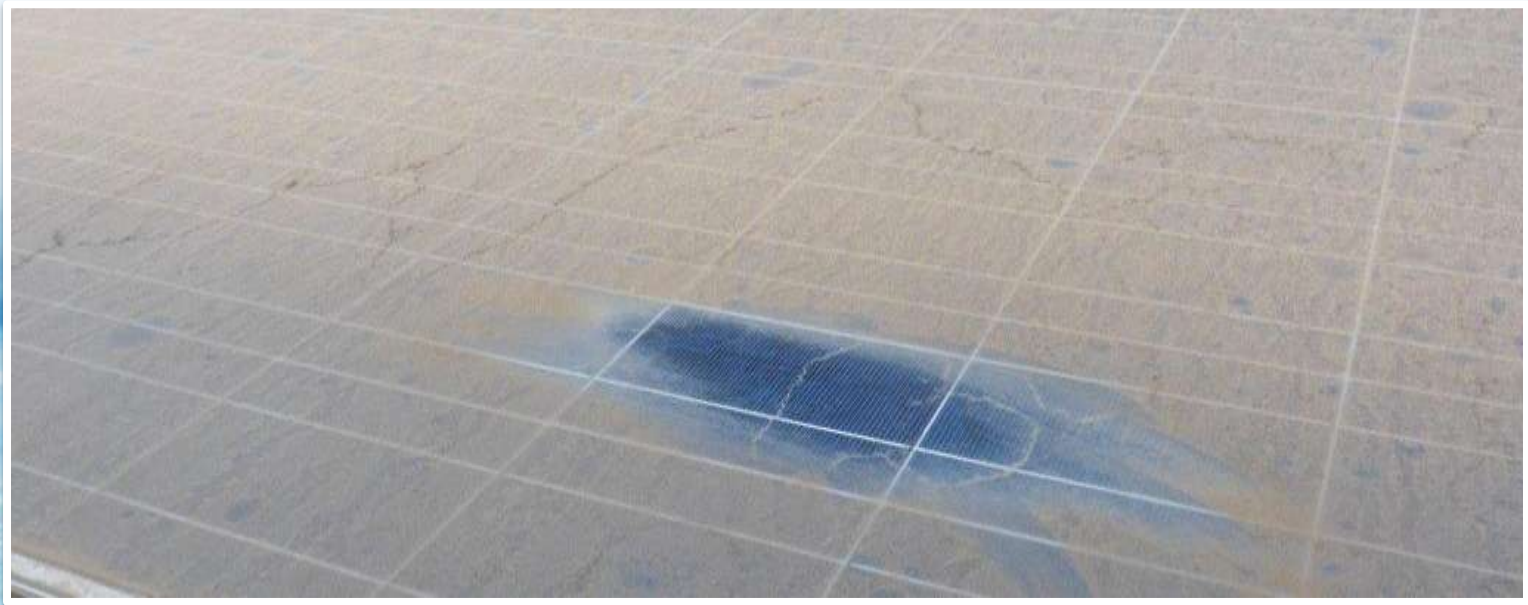
This photograph was taken in a company of agricultural plants in central California. Cleaning is carried out by spraying water on the panels by a truck every day. You can easily notice **strips of calcium** deposited using **hard water without filtration**. These panels have been installed since only two years and unlikely they can last more than two or three years without causing significant damage to the modules and the system output.

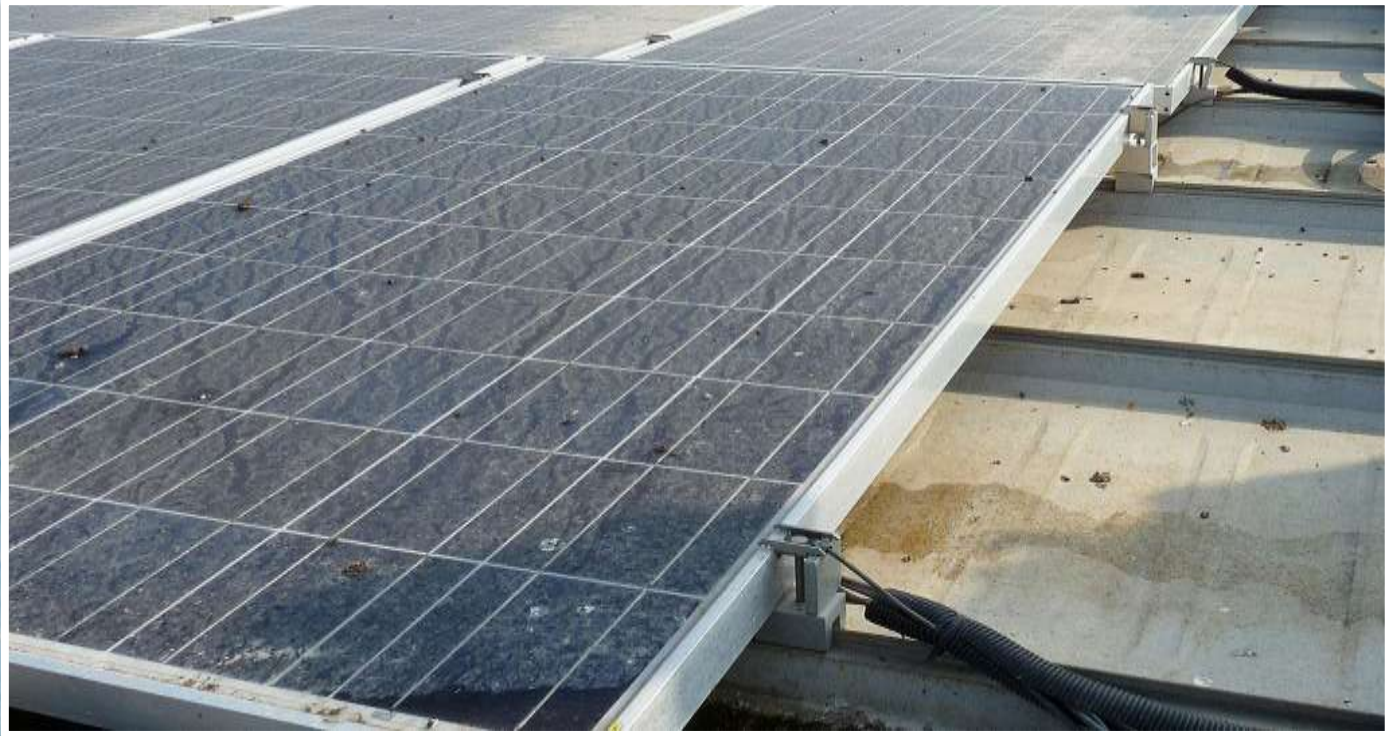
A photograph of a company of food products in Germany. There are many **droppings of birds** that have never been removed. This results in a substantial loss of yield due to the lack of frequent cleaning.

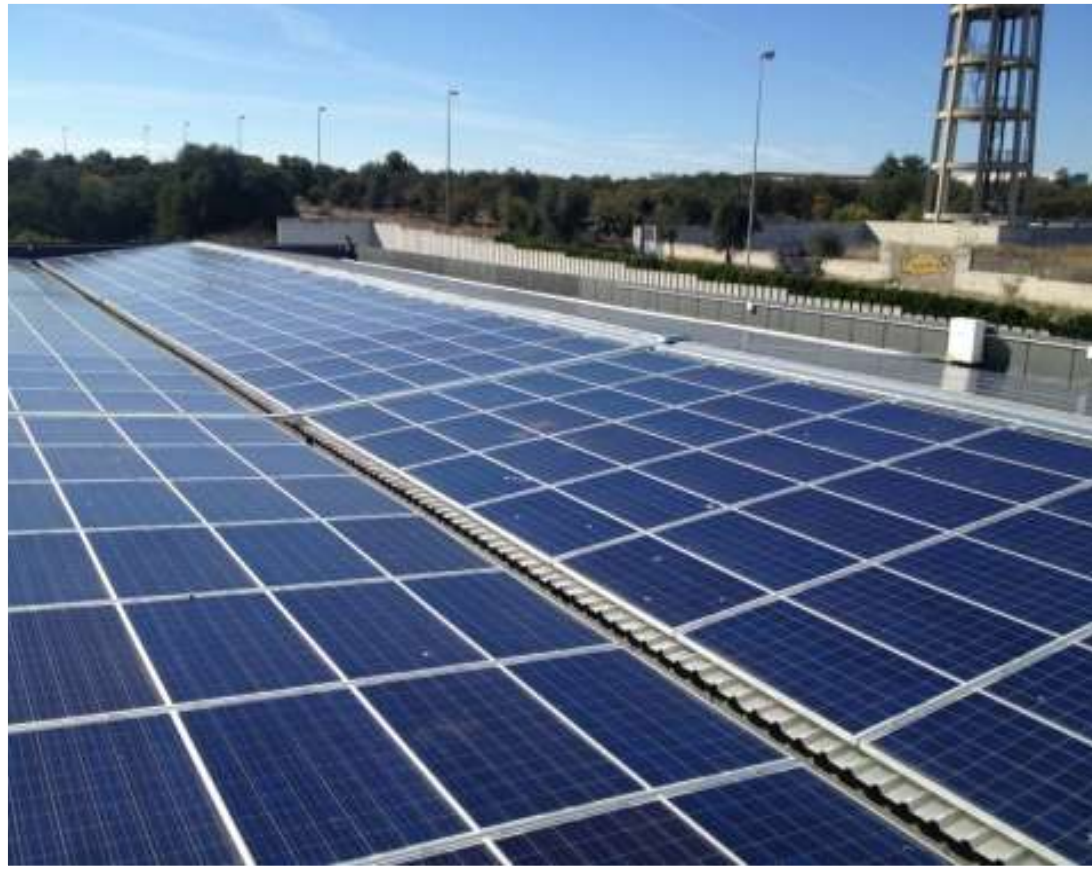
On the surface of these panels on the roof of a manufacturer of animal feed can be noticed residues of **pork rinds**, together with **droppings of seagulls**.

The residues deposited on the panel and, mainly due to the heat, became scaled very difficult to remove.

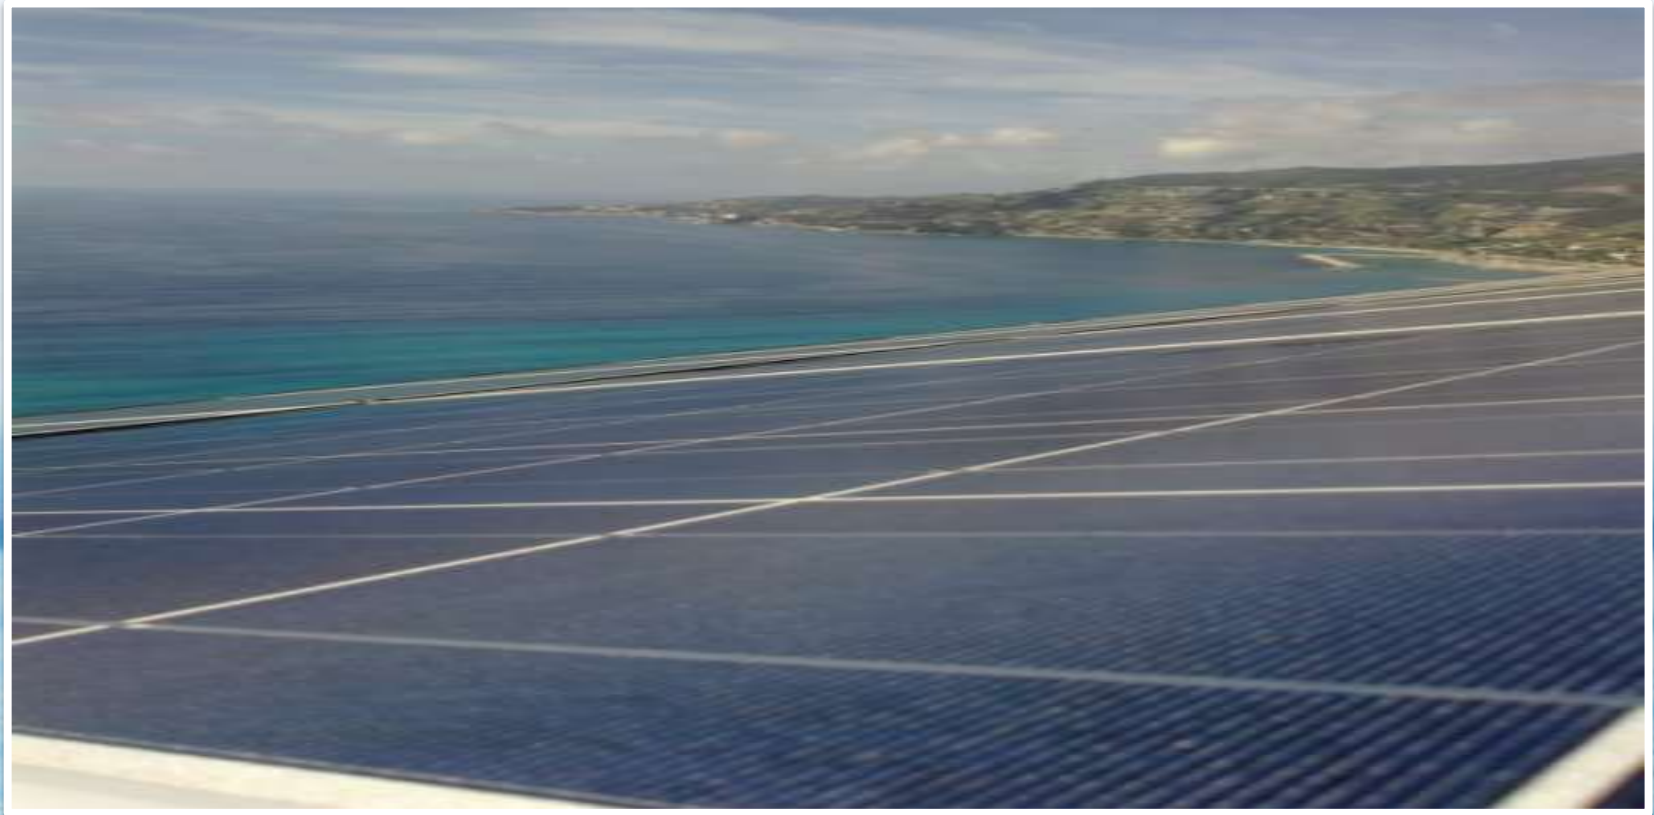
Greenhouse with photovoltaic system, proximity to the sea. Deposits of **salt** on the panels.

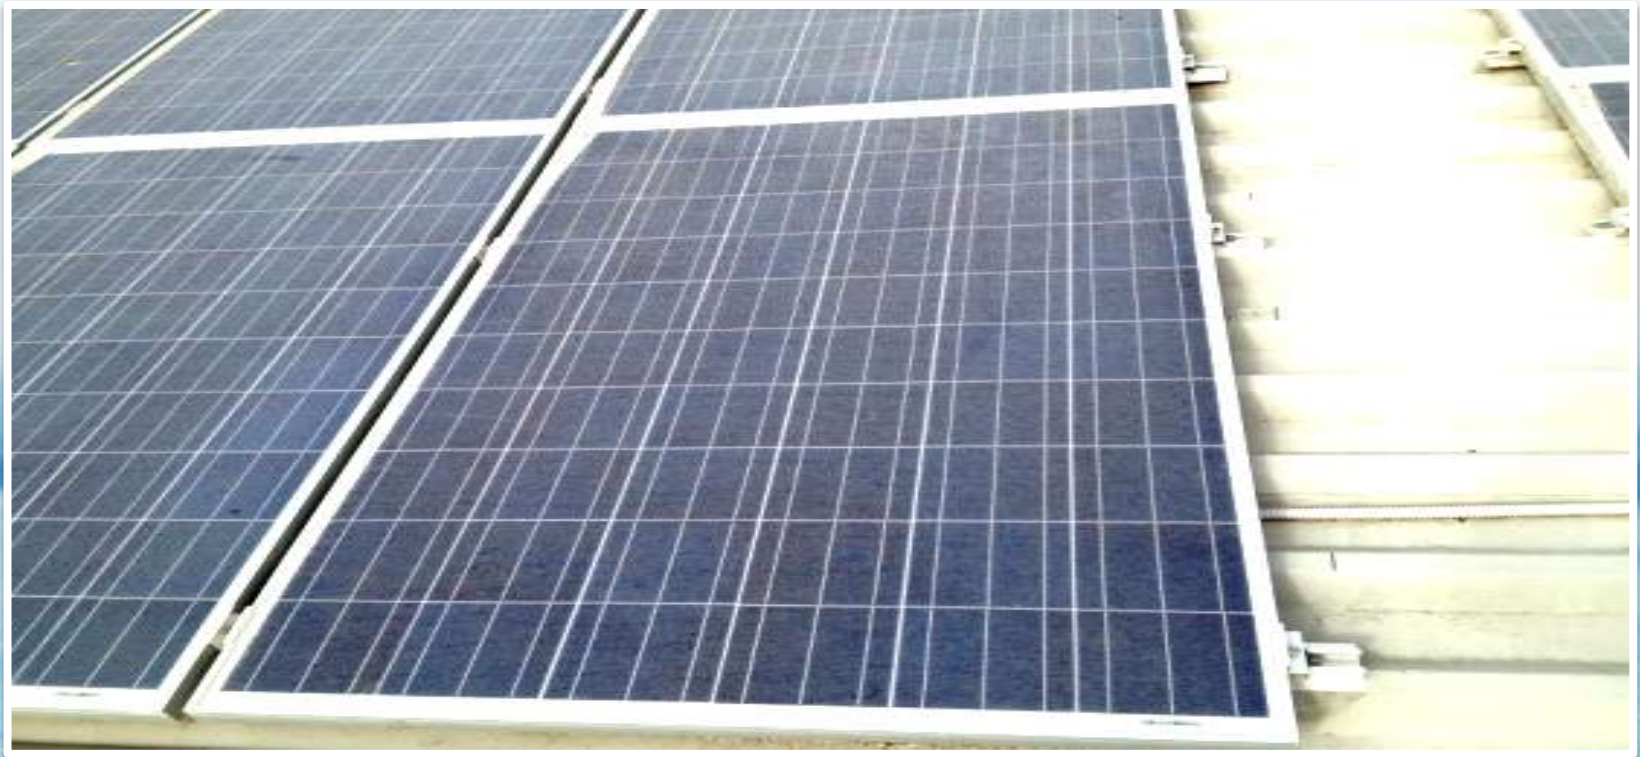
Deposits of **dirt** on panels on the roof of a farm of breeding pigs.
